**National Highway  
Traffic Safety  
Administration**

186-00

Case Vehicle (A): 1998 Plymouth  
Type: Breeze Expresso, 4-door sedan  
Driver: 57-year-old female  
CDC: 12-FZAW-4

Veh. (B): 1994 Peterbilt  
Type: Model 377 6 x 4 tractor with trailer  
Driver: 60-year-old male  
CDC: 99-0000-0

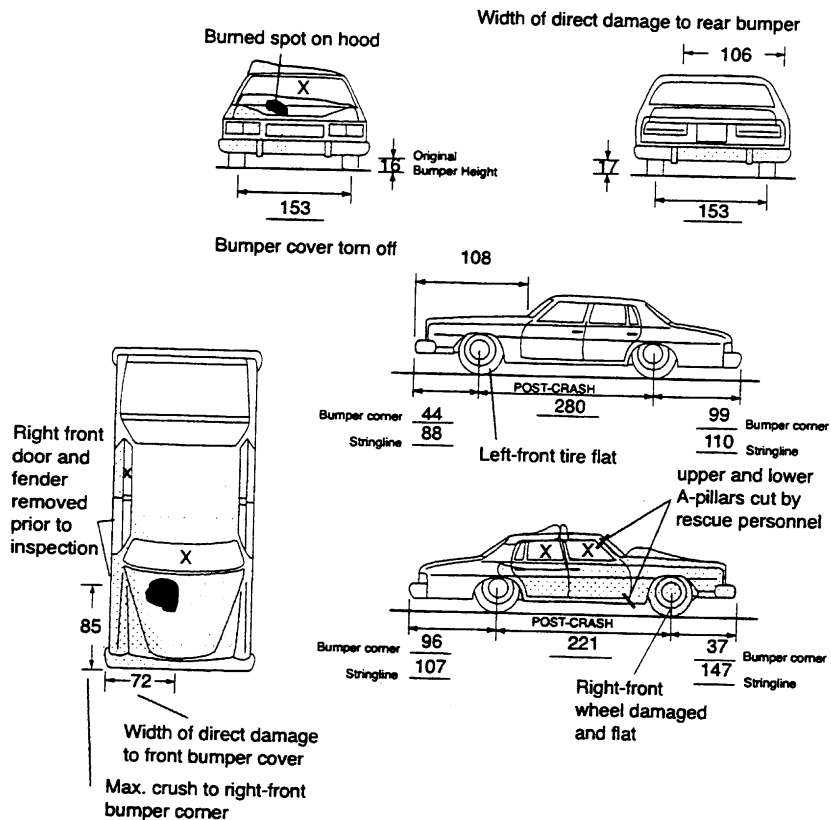
(Slide 4) Overall damage to case vehicle (A) was severe. (Slide 5) Direct damage to case vehicle (A) began at the right-front bumper corner and extended 72-cm to the left, resulting in 48-percent vehicle overlap. (Slide 6) Direct contact damage included the right-front roof. (Slide 7) The maximum crush was 85 cm to the right-front bumper.

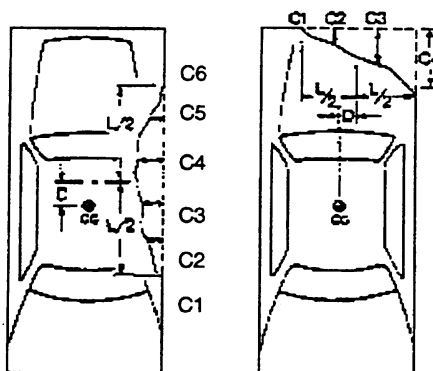
Specific Impact No.	Location of Direct Damage	Location of Field L
1	Begin Rt BC, 72 cm to left	FT Bumpers, BC to BC

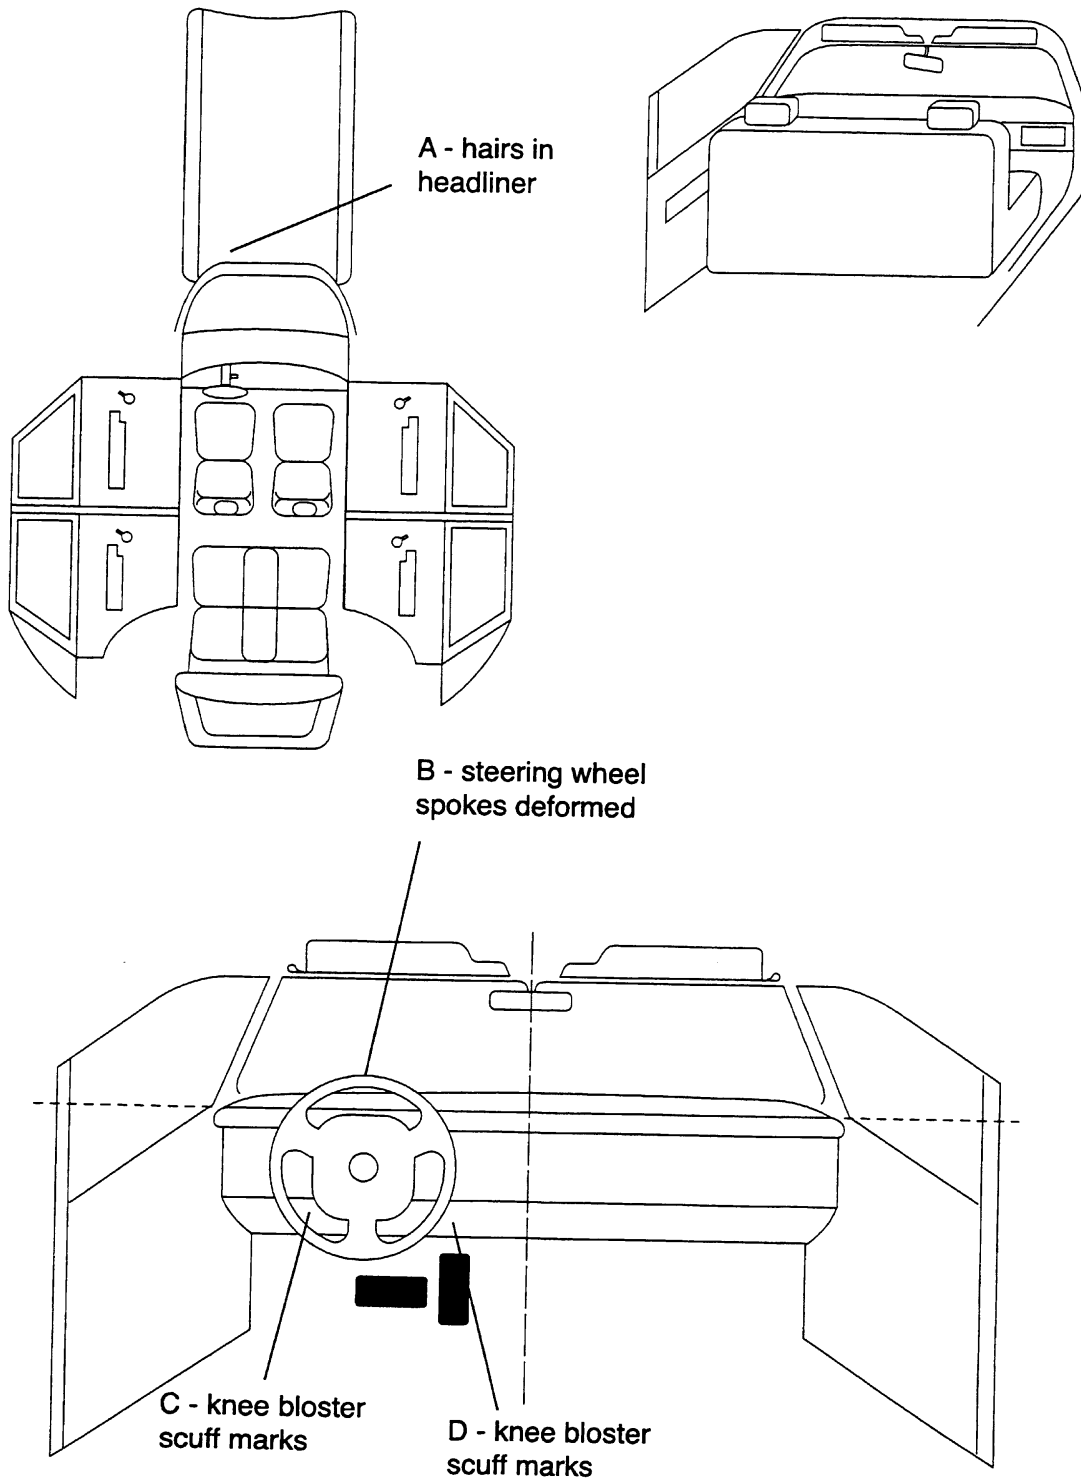
VEHICLE OCCUPANT CONTACT DIAGRAM

Contact	Interior Component Contacted	Occupant No. if Known	Body Region if Known	Supporting Physical Evidence	Confidence Level of Contact Point
A	Windshield Header	DR	Head	Hairs in headliner	2
B	Steering wheel	DR	Chest	Spokes deformed	1
C	Knee bolster	DR	Lt. leg	Scuff marks	1
D	Knee bolster	DR	Rt. Leg	Scuff marks	1
E					
F					
G					
H					
I					
J					
K

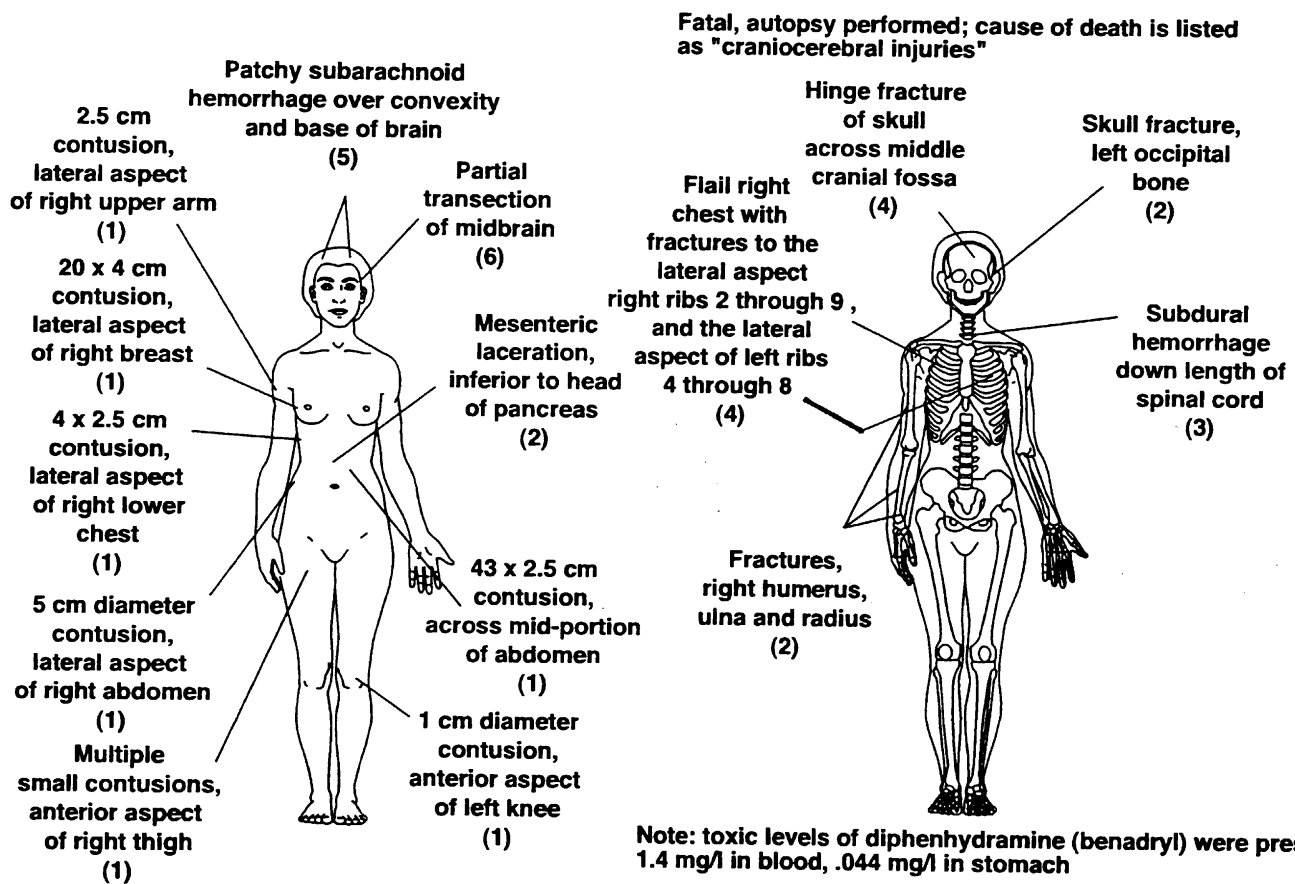
The following table and attached drawing (slide 78) summarize the injuries for the driver of case vehicle (A).
